**HUD  
Engineering Certification  
Report**

Prepared for: ██████████

Mar 9, 2026 at 10:09:33 AM

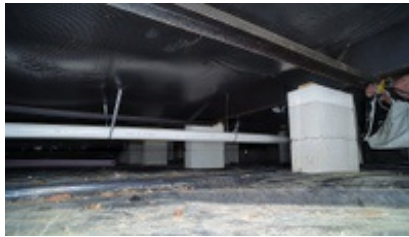
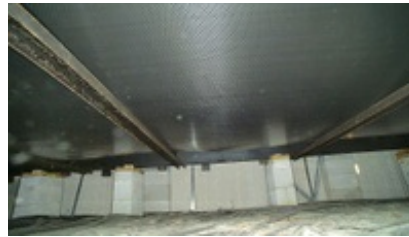
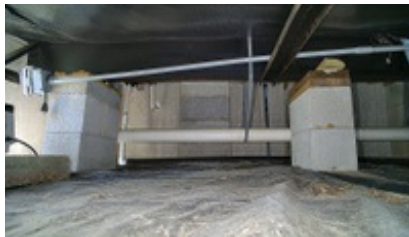
**1.17 Foundation Type Images**

Crawlspace

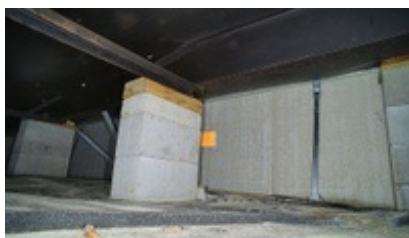
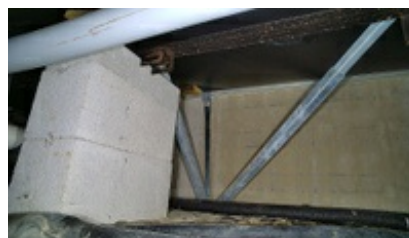
**1.19 Piers and/or Support Column Images**

Concrete Masonry Units

Plastic Pad

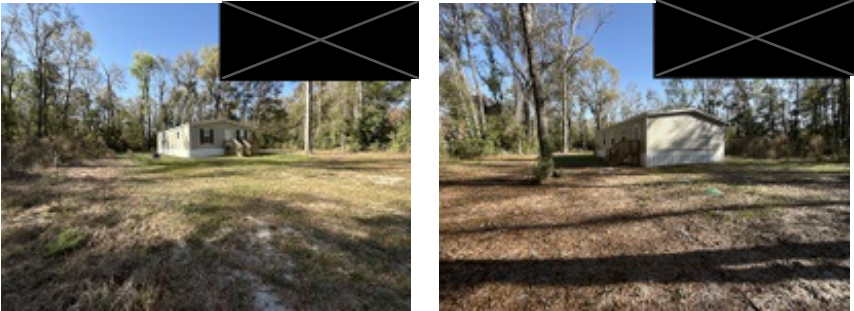
### 2.2 Exterior Grading Images

Reasonable grading around the home.

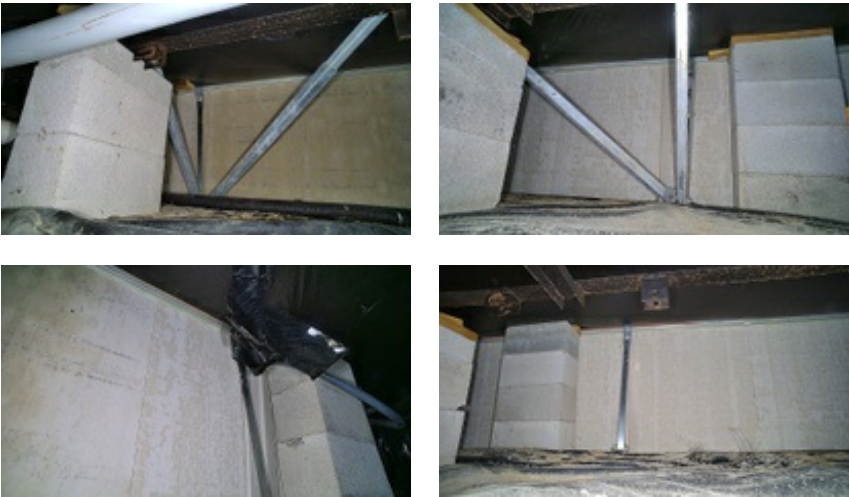
### 2.5 Anchor Method Images

Metal Straps connected to anchors augured into the soil (spacing every 5 feet), Proprietary Restraint System (Front right, Front left, Back right, and Back left)

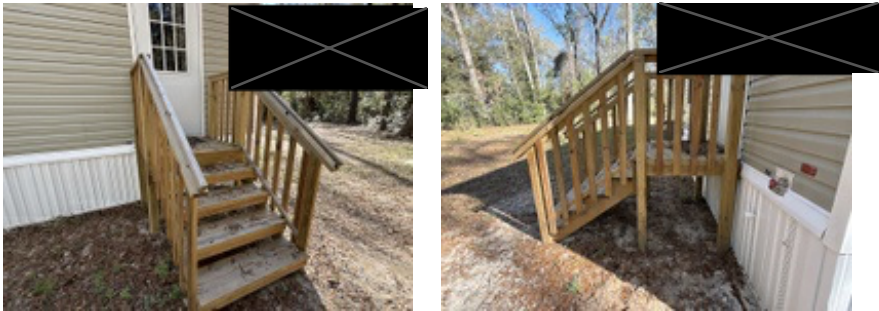
**3.2 Images**

Right Side

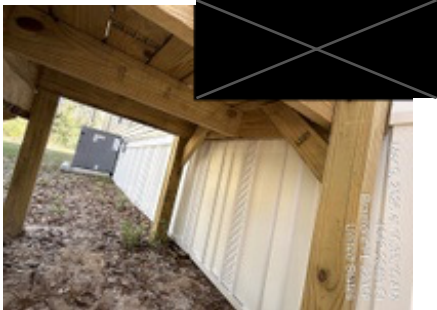
**3.4 Floor Structure Images**

No loads are being transferred from the floor structure onto the structure of the manufactured home.

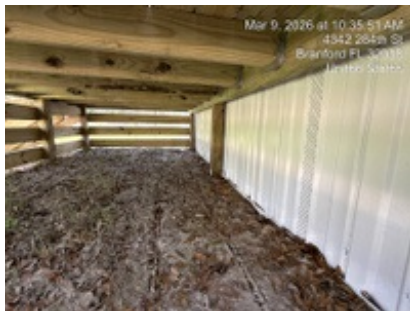
### 3.10 Floor Structure Images

No loads are being transferred from the floor structure onto the structure of the manufactured home.
