SUMMARY

1234 Main Street Lake City FL 32024

Mark Rogers
InterNACHI Certified Home Inspector
High Mark Inspections LLC
(305) 213-7607
info@highmarkinspections.com

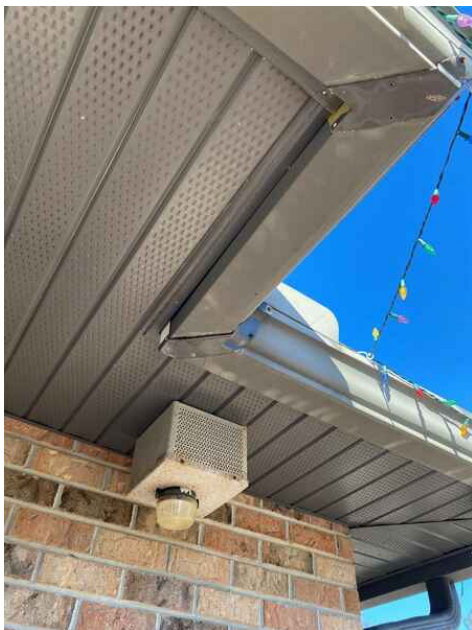
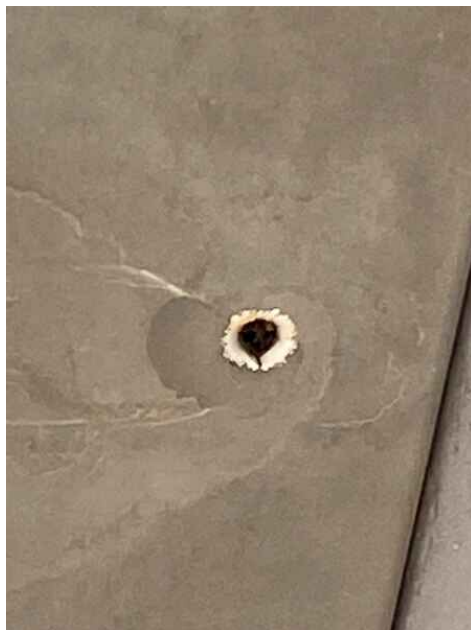
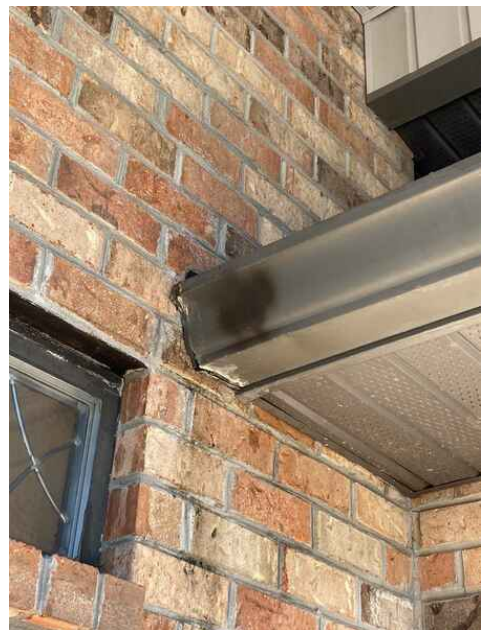
3.2.1 Roof Drainage System

GUTTERS: LEAKING AT AREAS- QC

The gutters were leaking at various areas and needed maintenance such as the application of an appropriate sealant. This condition can result in excessively high moisture levels in soil at the foundation and can cause damage related to soil/foundation movement. Excessive moisture levels in soil near the foundation can effect the ability of the soil to support the weight of the structure above and can cause damage related to soil/foundation movement. The Inspector recommends repair to help protect the home structure. All work should be performed by a qualified contractor.

Small puncture

Contact a qualified professional.

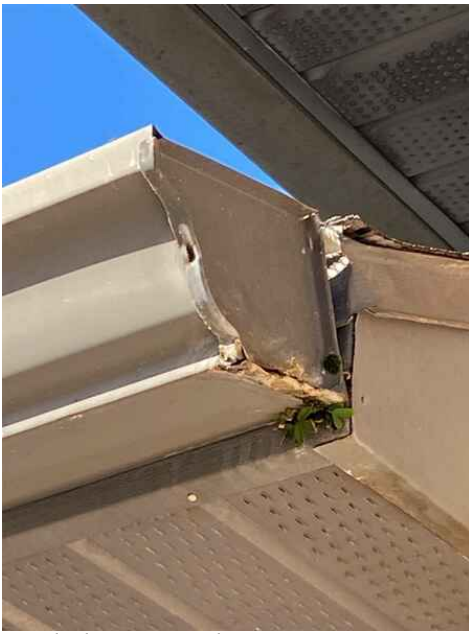
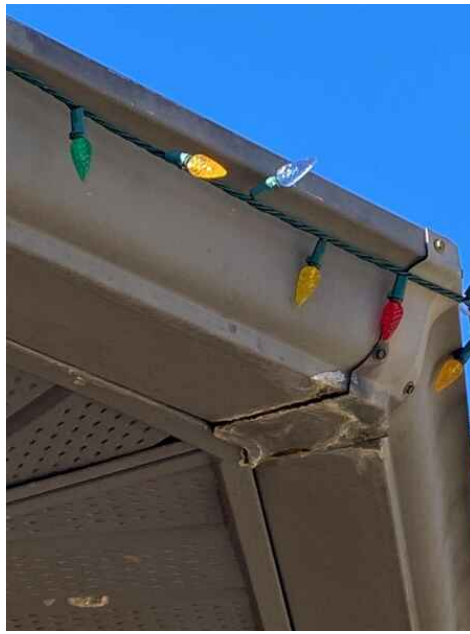
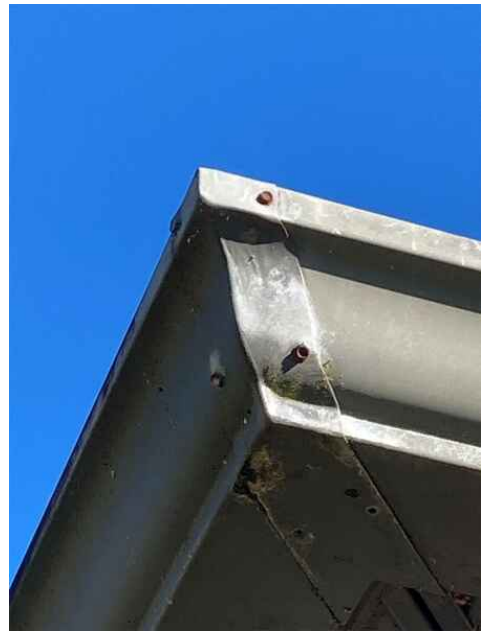
Corroded gutter end cap

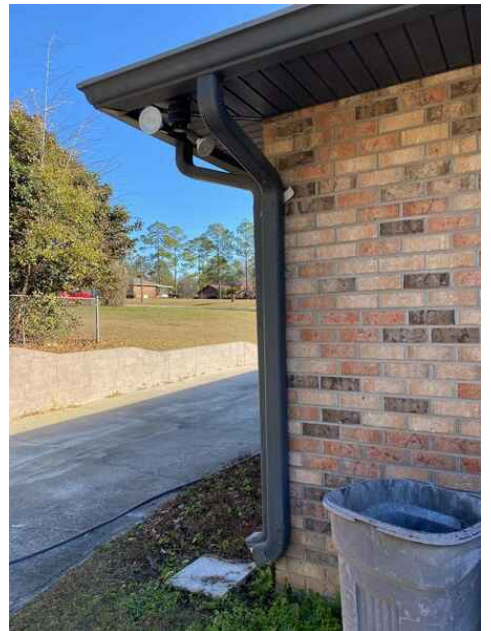
3.2.2 Roof Drainage System

GUTTERS DISCHARGING NEAR FOUNDATION

NORTH WEST CORNER

The gutter down spouts are discharging water near the foundation and causing soil erosion. I recommend gutter extenders or splash pads to help carry water further from the home.

Contact a qualified gutter contractor

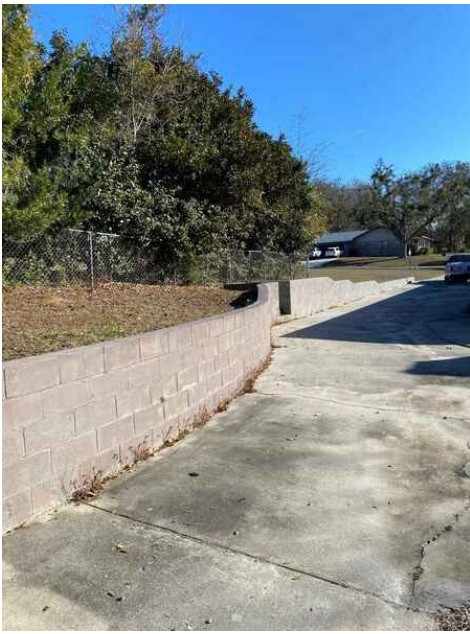
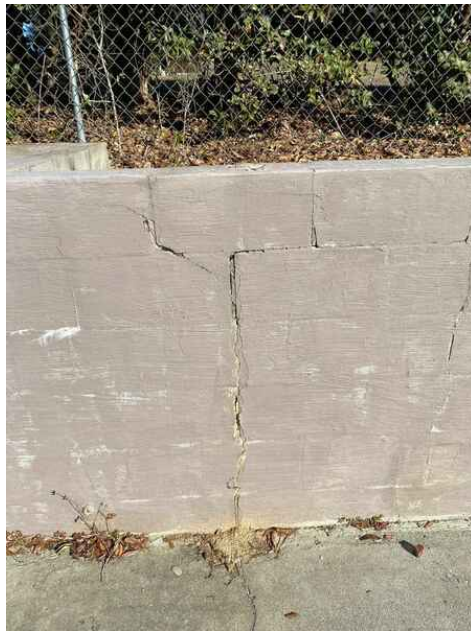
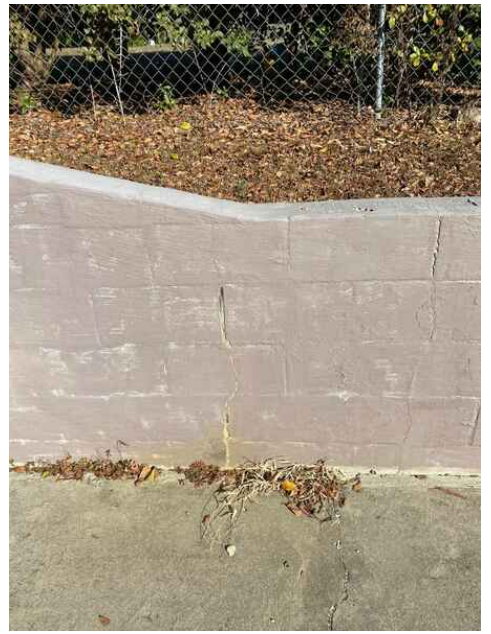
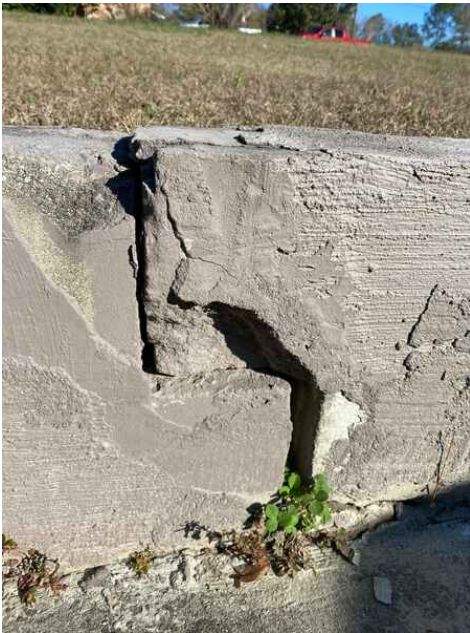
4.1.1 Grounds

RETAINING WALL CONCRETE BLOCK WAS CRACKED IN MULTIPLE LOCATIONS. VISUAL INSPECT ANNUALLY FOR SIGNS OF FURTHER DETERIORATION.

Contact a qualified professional.

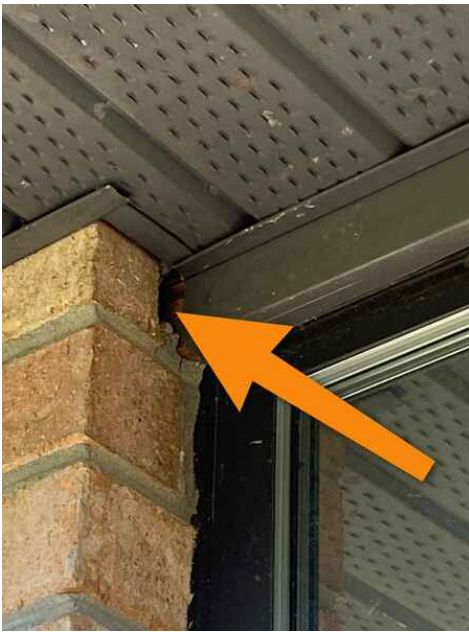
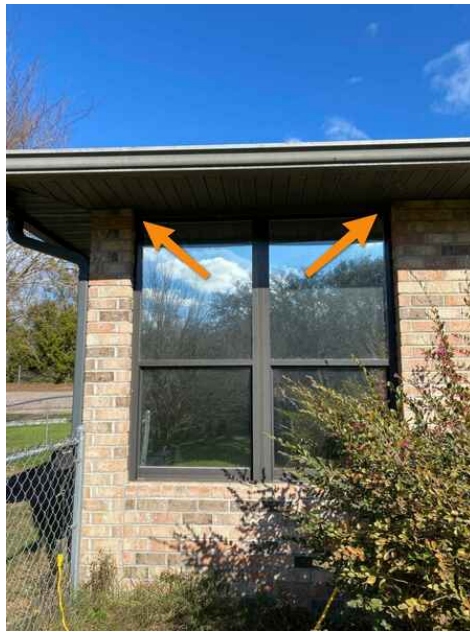
4.4.1 Door/Window Exteriors

WINDOW SEALANT.

Repointing of wall window heder needed. South West window.

South West window

Contact a qualified professional.

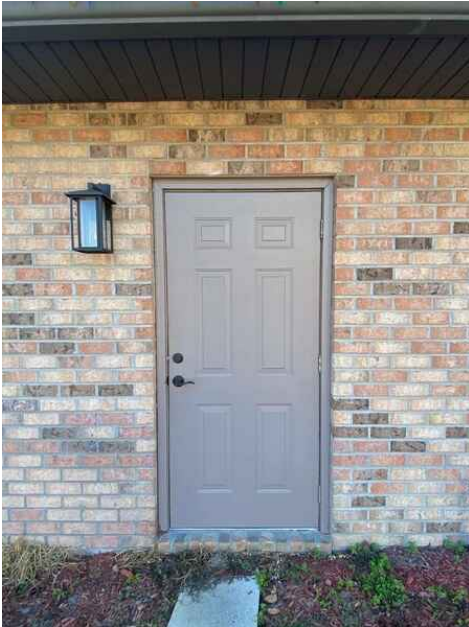
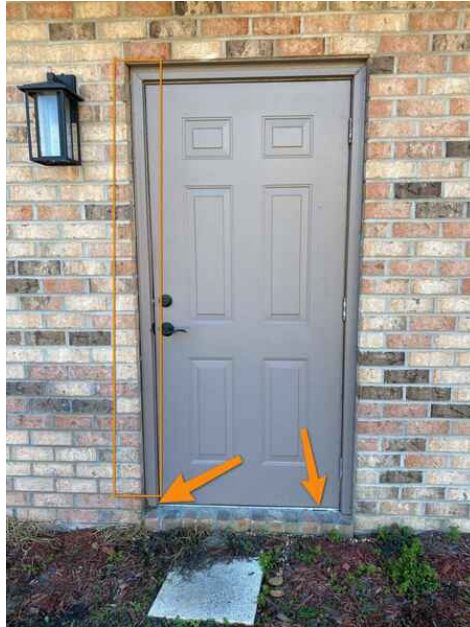
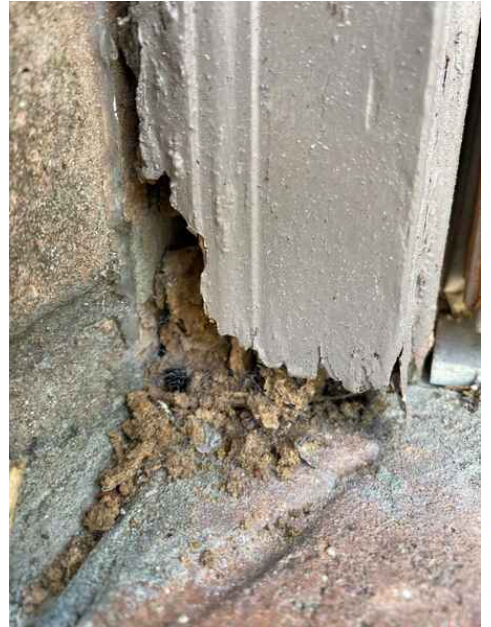
4.5.1 Exterior Trim

DOOR TRIM: DECAY, ADVANCED- QC

Door trim had advanced decay visible in areas. The inspector recommends replacement by a qualified contractor.

Contact a qualified professional.

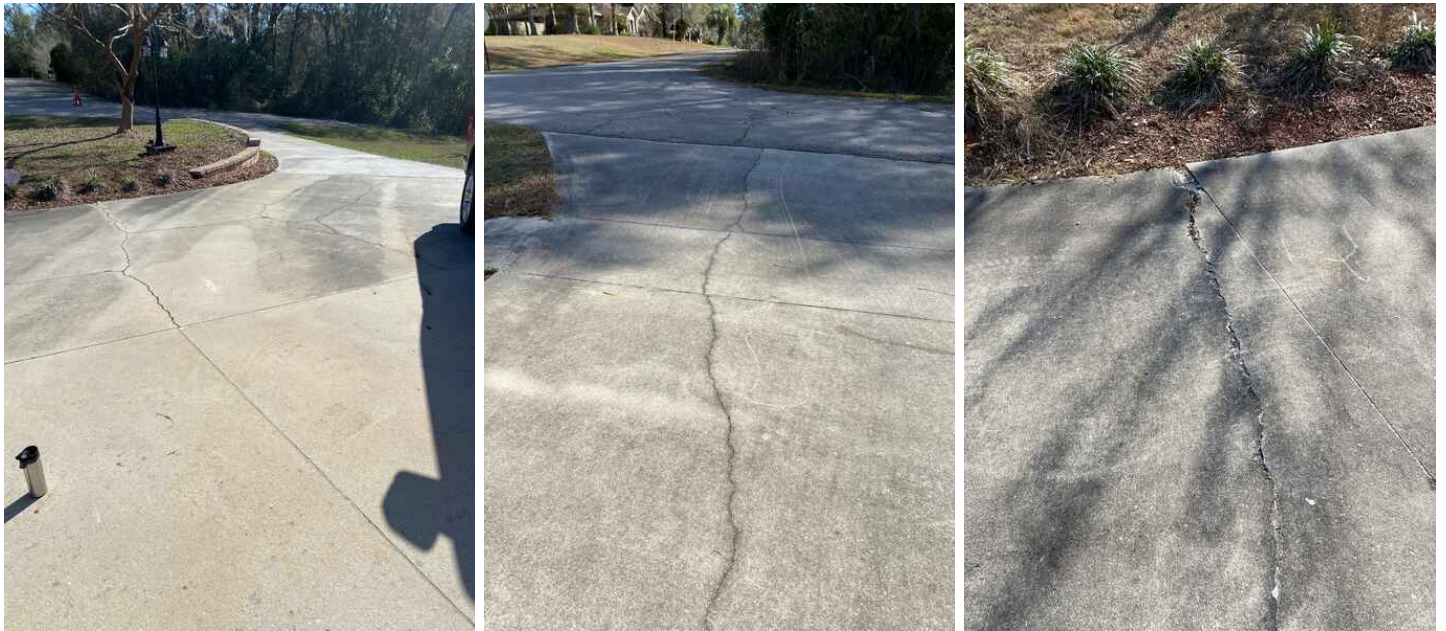
4.7.1 Driveway

CRACKS: COMMON CRACKS < 1/4"

Common cracks (1/4-inch or less) were visible in the driveway. Cracks exceeding 1/4 inch should be filled with an appropriate material to avoid continued damage to the driveway.

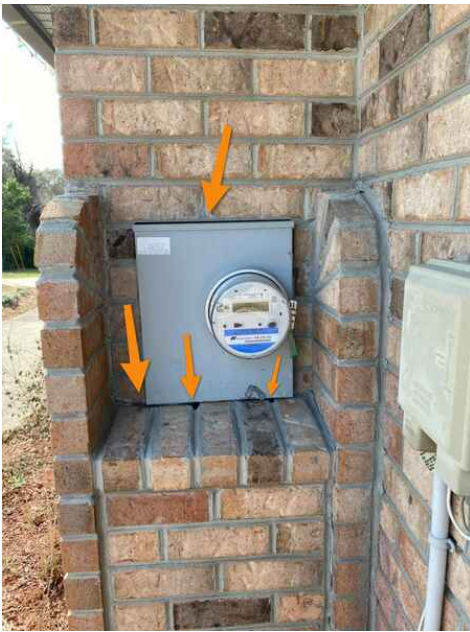
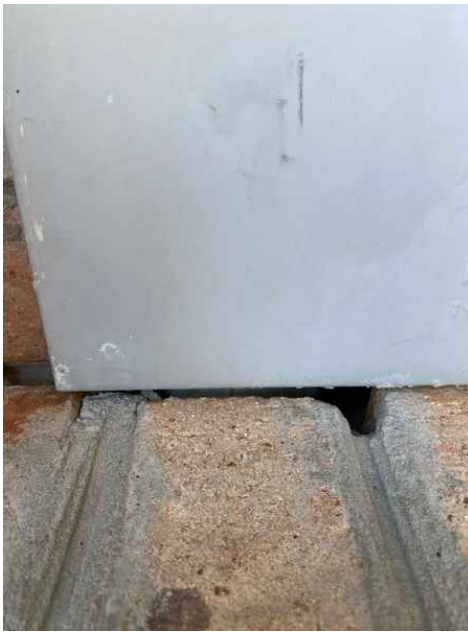
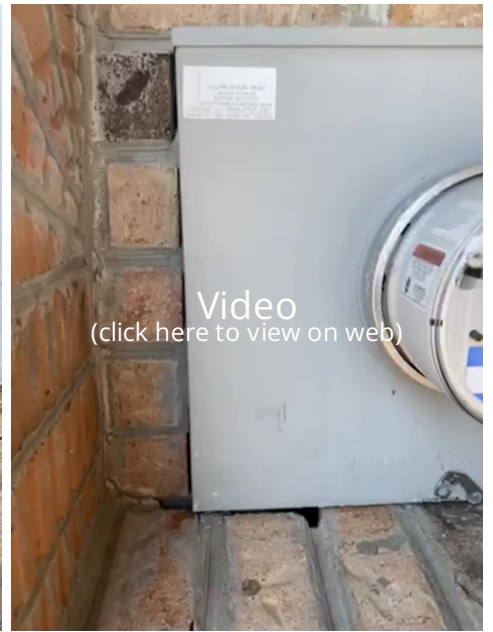
5.1.1 Electric Meter

METER SEAL TO WALL

Meter-to-wall connection should be caulked or repointed by a mason to prevent moisture penetration behind the brick wall around the meter.

Contact a qualified professional.

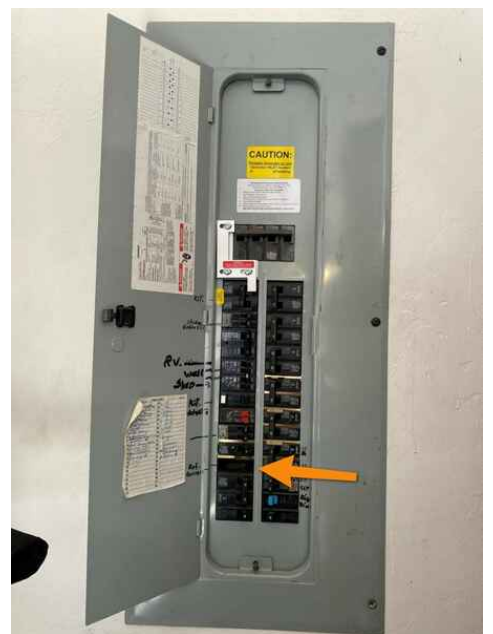
5.2.1 Main Service Disconnect Panel

**Serious Concern/Action Needed**

DEAD FRONT COVER: FILLER PLATES MISSING- QC

Filler plates missing in the Dead front cover of the electrical service panel may allow a person to come into contact with energized electrical components. This condition is a potential shock/electrocution hazard and should be corrected by a qualified electrical contractor.

Contact a qualified electrical contractor.

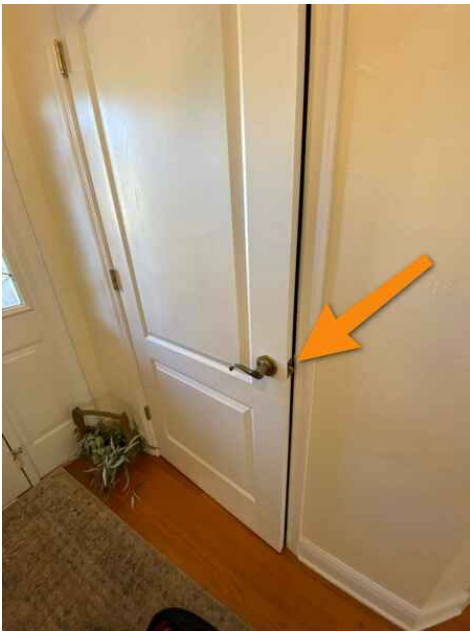
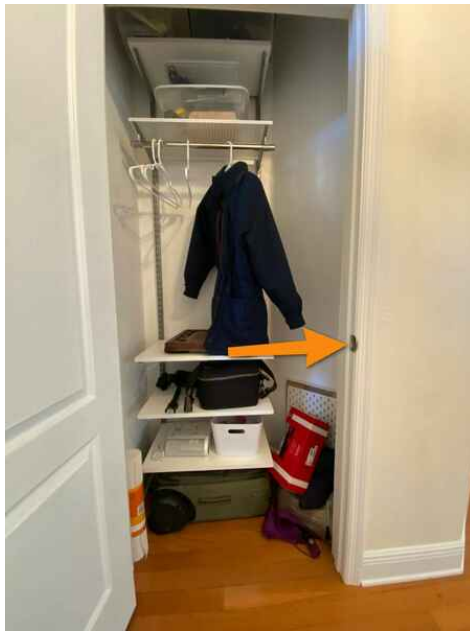
7.2.1 Foyer

FOYER CLOSER DOOR LATCH NEEDA ADJUSTMENT.

FOYER CLOSET

Contact a qualified professional.

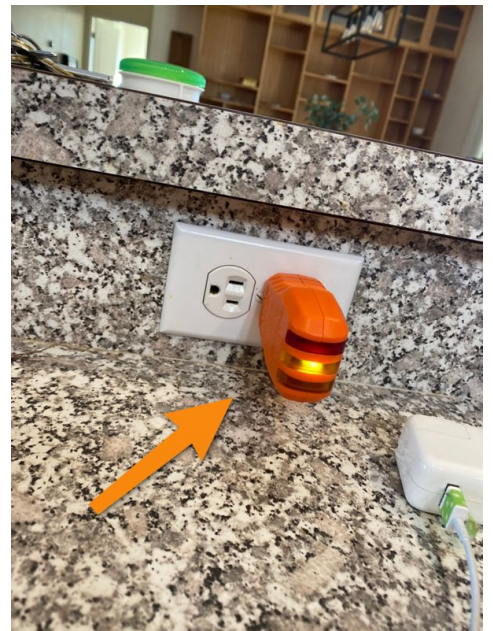
7.3.1 Kitchen

ELECTRICAL RECEPTICALS: GFCI MULTIPLE FAILURES- QC

Serious Concern/Action Needed

Multiple ground fault circuit interrupter (GFCI) electrical receptacles in the kitchen did not respond to testing, did not re-set, were slow to re-set or made a buzzing sound when re-set. This indicates that the condition of GFCI electrical receptacles in the kitchen is deteriorating. This is a safety issue. The Inspector recommends replacement of all interior and exterior GFCI receptacles to ensure that they work correctly when required. All work should be performed by a qualified contractor.

Contact a qualified electrical contractor.

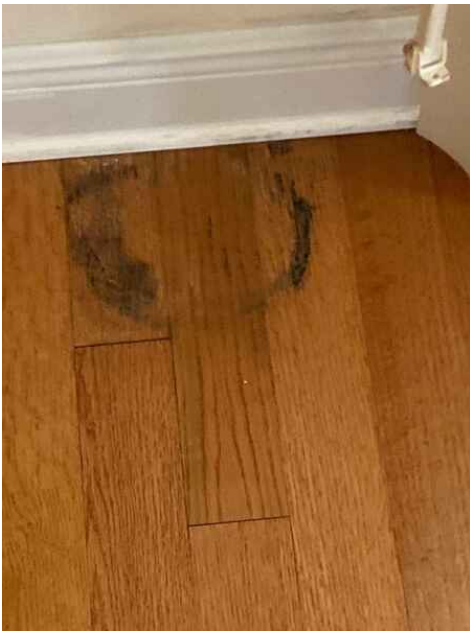
7.4.1 Dining Room

HARDWOOD FLOOR STAIN

Hardwood floor and dining room has a stand next to the sliding glass door on the left-hand side.

Left side of sliding glass door

Contact a qualified professional.

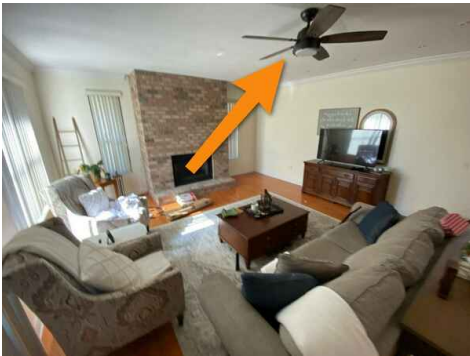
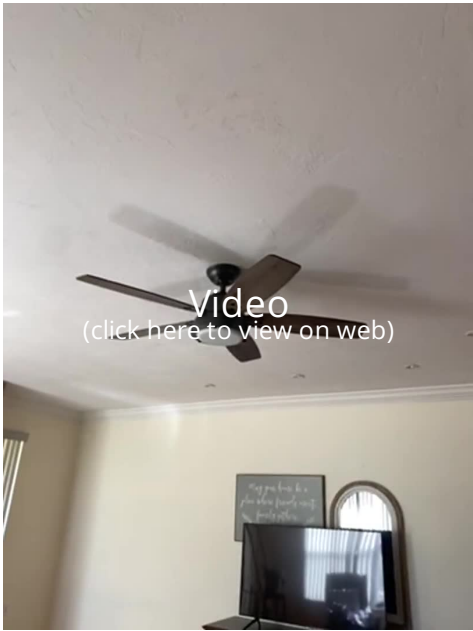
7.6.1 Living Room
CEILING FAN(S): INOPERABLE- QC

The ceiling fan in the living room was inoperable. The Inspector recommends an evaluation and any necessary work be performed by a qualified electrical contractor.

Recommendation
Contact a qualified electrical contractor.

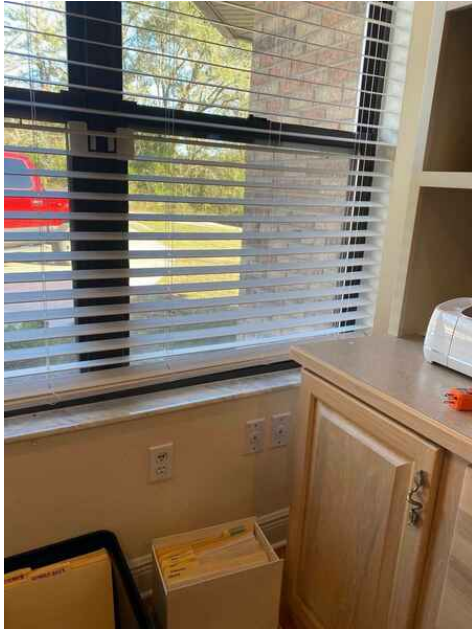
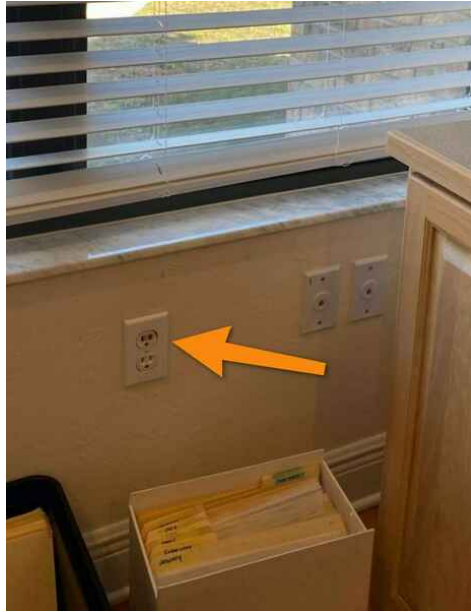
ELECTRICAL RECEPTACLE: DAMAGED-QC

Serious Concern/Action Needed

This office had a damaged electrical receptacle that should be replaced by a qualified electrical contractor.

East office

Contact a qualified electrical contractor.

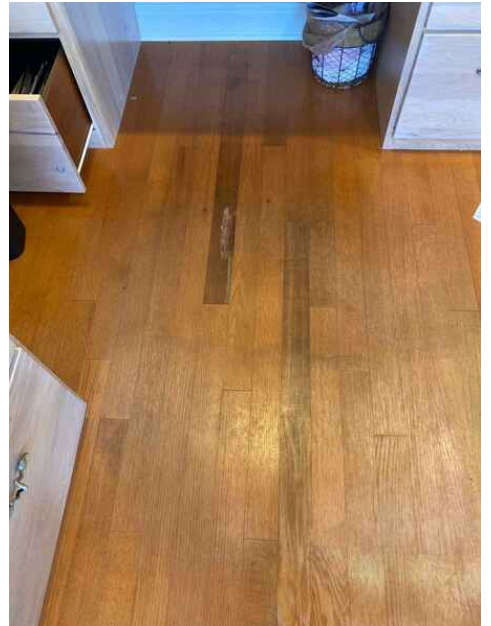
HARDWOOD FLOOR

The flooring is damaged in the area in front of the desk, where a chair would most likely sit

Recommend evaluation and repair by a qualified flooring specialist.

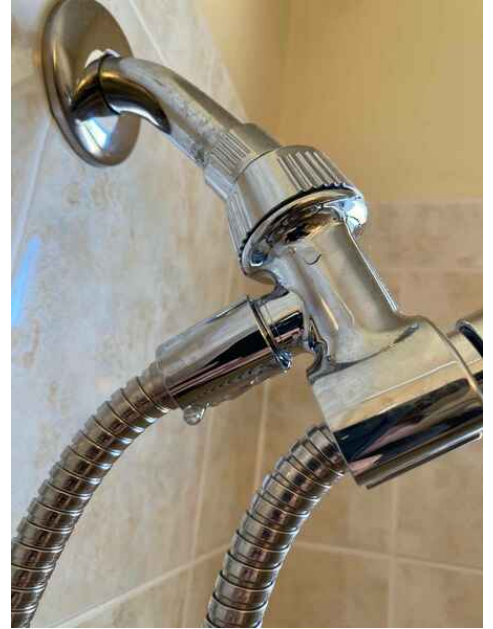
7.11.2 Bathroom 1

SHOWER: SHOWERHEAD LEAKING- QC

The shower head connection leaked when the shower was operated. The inspector recommends service by a qualified plumbing contractor.

Contact a qualified handyman.

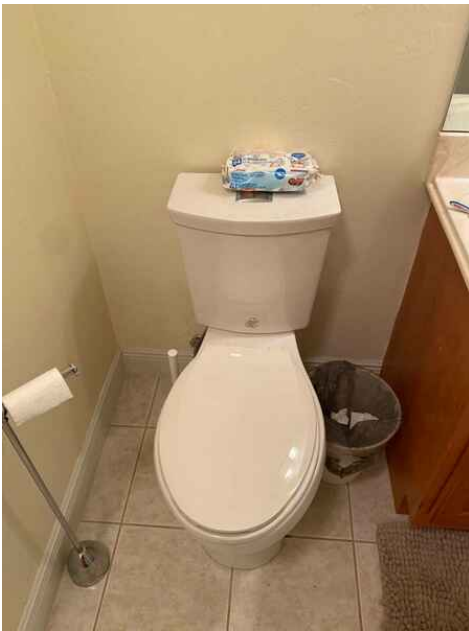
7.12.1 Bathroom 2

TOILET: LOOSE - QC

In this bathroom, the toilet was loose at the floor indicating that fasteners designed to secure the toilet to the floor have loosened and need to be retightened. The Inspector recommends re-attached by a qualified contractor.

Contact a qualified professional.

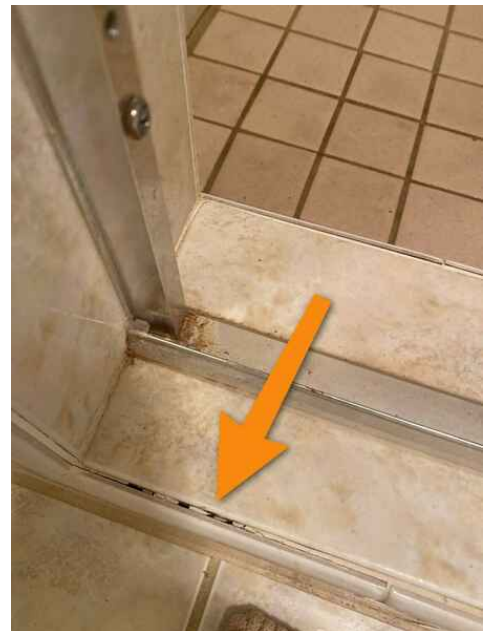
7.12.2 Bathroom 2

SHOWER: GROUT MISSING- QC

The shower tiles had areas of missing grout that may allow moisture to penetrate the walls. The inspector recommends service by a qualified plumbing contactor.

Contact a qualified tile contractor

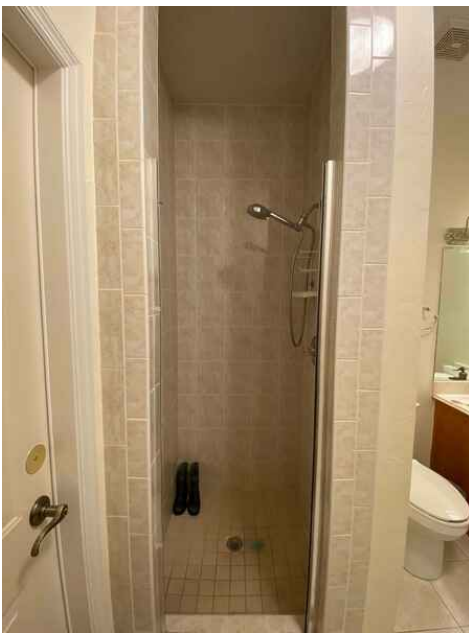
7.12.3 Bathroom 2

SHOWER DOOR MISSING

At the time of inspection, the shower door was missing.

Contact a qualified professional.

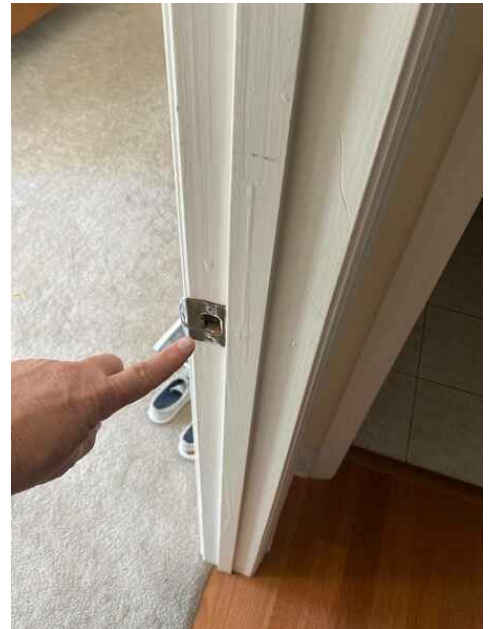
7.13.1 Bedroom Owner Suite

DOOR, INT.: LATCH BOLT MISALIGNED- QC

At an interior door in this bedroom, the doorknob latch bolt did not align with the hole in the strike plate and did not hold the door closed. The Inspector recommends adjustment by a qualified contractor.

Contact a qualified professional.

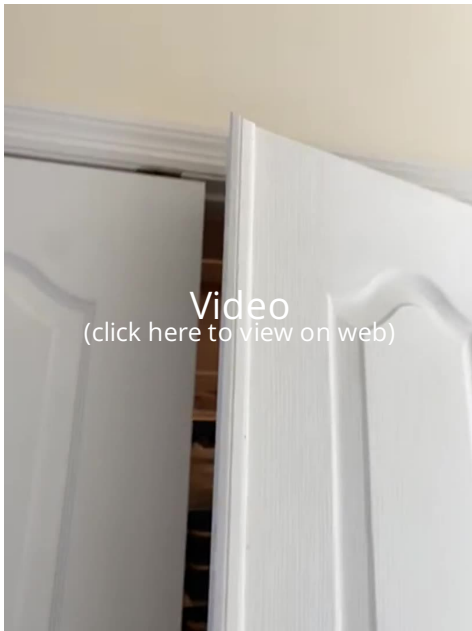
7.13.3 Bedroom Owner Suite

SOUTH CLOSET DOOR, INT.: HARDWARE DAMAGE/DETERIORATION, MINOR

An interior door hardware in this bedroom exhibited minor damage or deterioration.

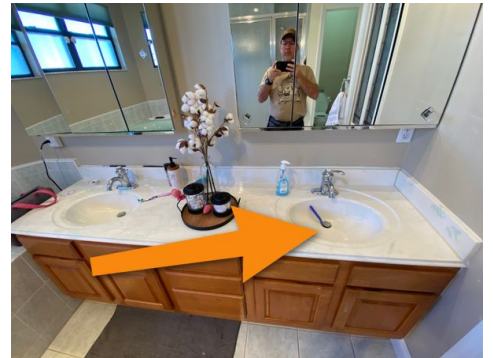
7.14.1 Bathroom Owners Suite

SINKS: STOPPER, 1 INOPERABLE- QC

One sink in this bathroom had an inoperable stopper. The Inspector recommends service by a qualified contractor.

Contact a qualified professional.

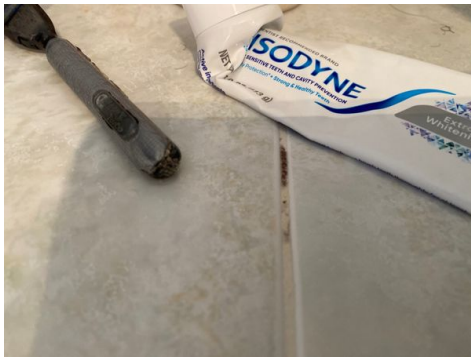
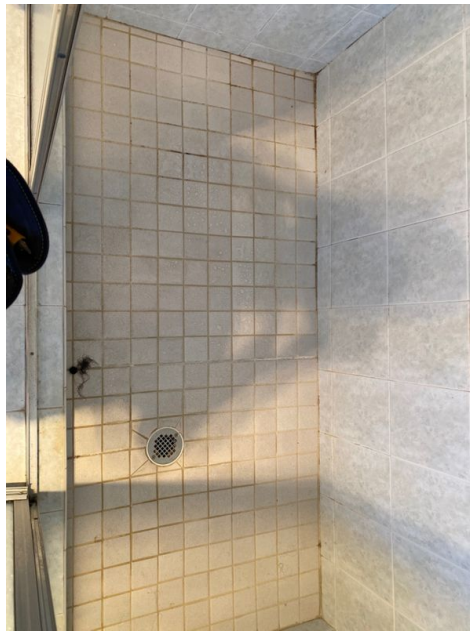
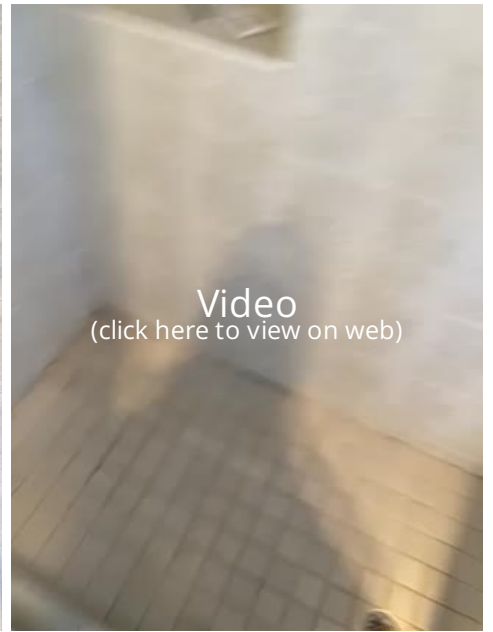
7.14.2 Bathroom Owners Suite

SHOWER: GROUT MISSING- QC

The shower tiles had areas of missing grout that may allow moisture to penetrate the walls. The inspector recommends service by a qualified plumbing contractor.

Contact a qualified tile contractor

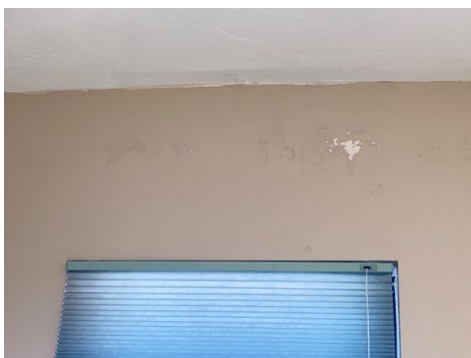
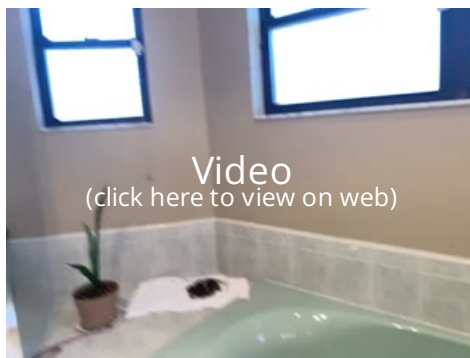
7.14.4 Bathroom Owners Suite

WALLS: DRYWALL/ PAINT FINISH

The inspector noted some area of the wall finish that need attention either in painting or drywall finish.

Contact a qualified general contractor.

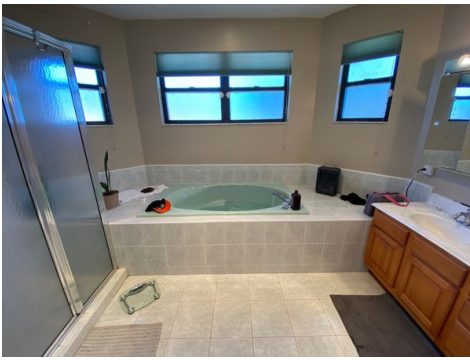
7.14.5 Bathroom Owners Suite

BATHTUB W/JETS: PUMP, NO ACCESS

No hatch was provided for access to the pump for the whirlpool tub. A hatch should be provided to allow for inspection, service and repair of tub, pump and electrical equipment.

Contact a qualified handyman.

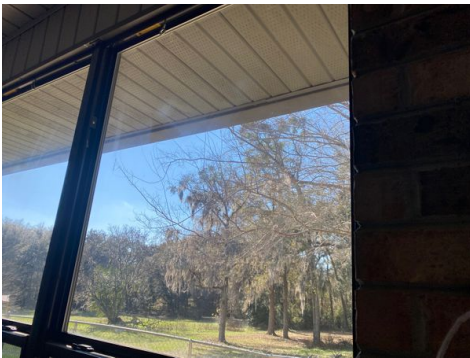
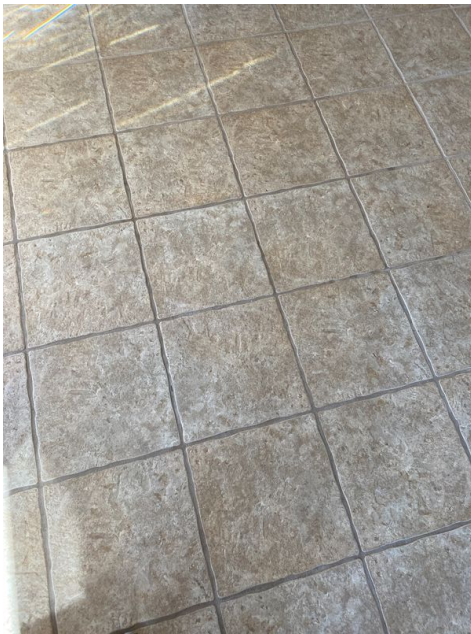
7.17.1 Florida Room
INSULATED WINDOW FAILURE

Insulated window failure

Recommendation
Contact a qualified professional.
